BULGARIAN FIGHTER COLOURS 1919–1948

Vol. 1

Rainbow No 9136

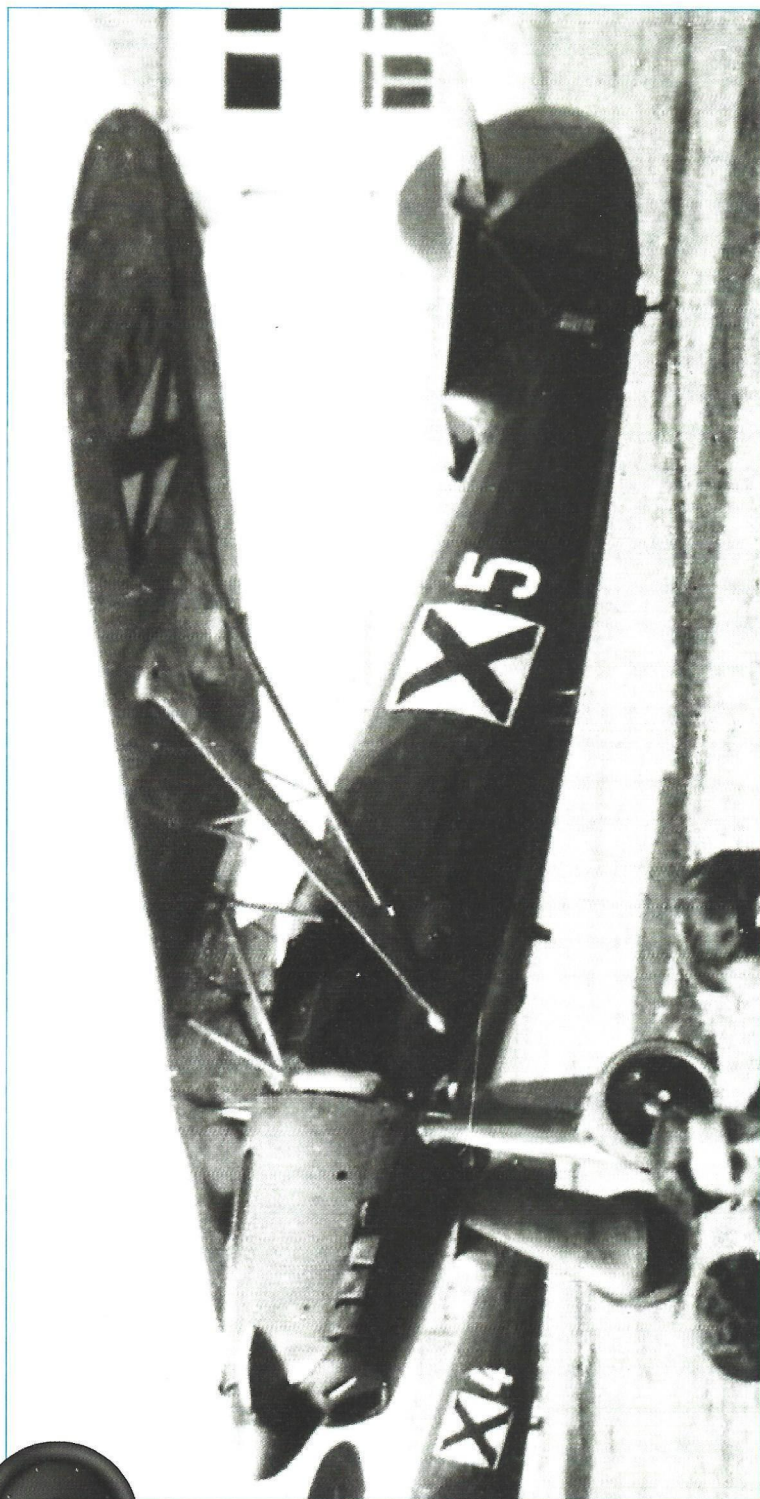
Focke-Wulf Fw 56A-1 Komar, 5/7003, 'White 5', 6. Iztrebitelen Polk (6th Fighter Regiment), Kazanlák, 1943. Camouflage colours: Dark Green upper surfaces, Light Blue under surfaces. Cross-style national marking in six positions. Yellow engine cowling and rudder. Red fuselage flash. Spinner Black/Yellow.

The tree-quarter view of Komar No. 5 reveals the marking and code applied on the lower wing surface. The engine cowling and rudder had been painted in yellow Axis recognition colour. The fuselage flash is in red.

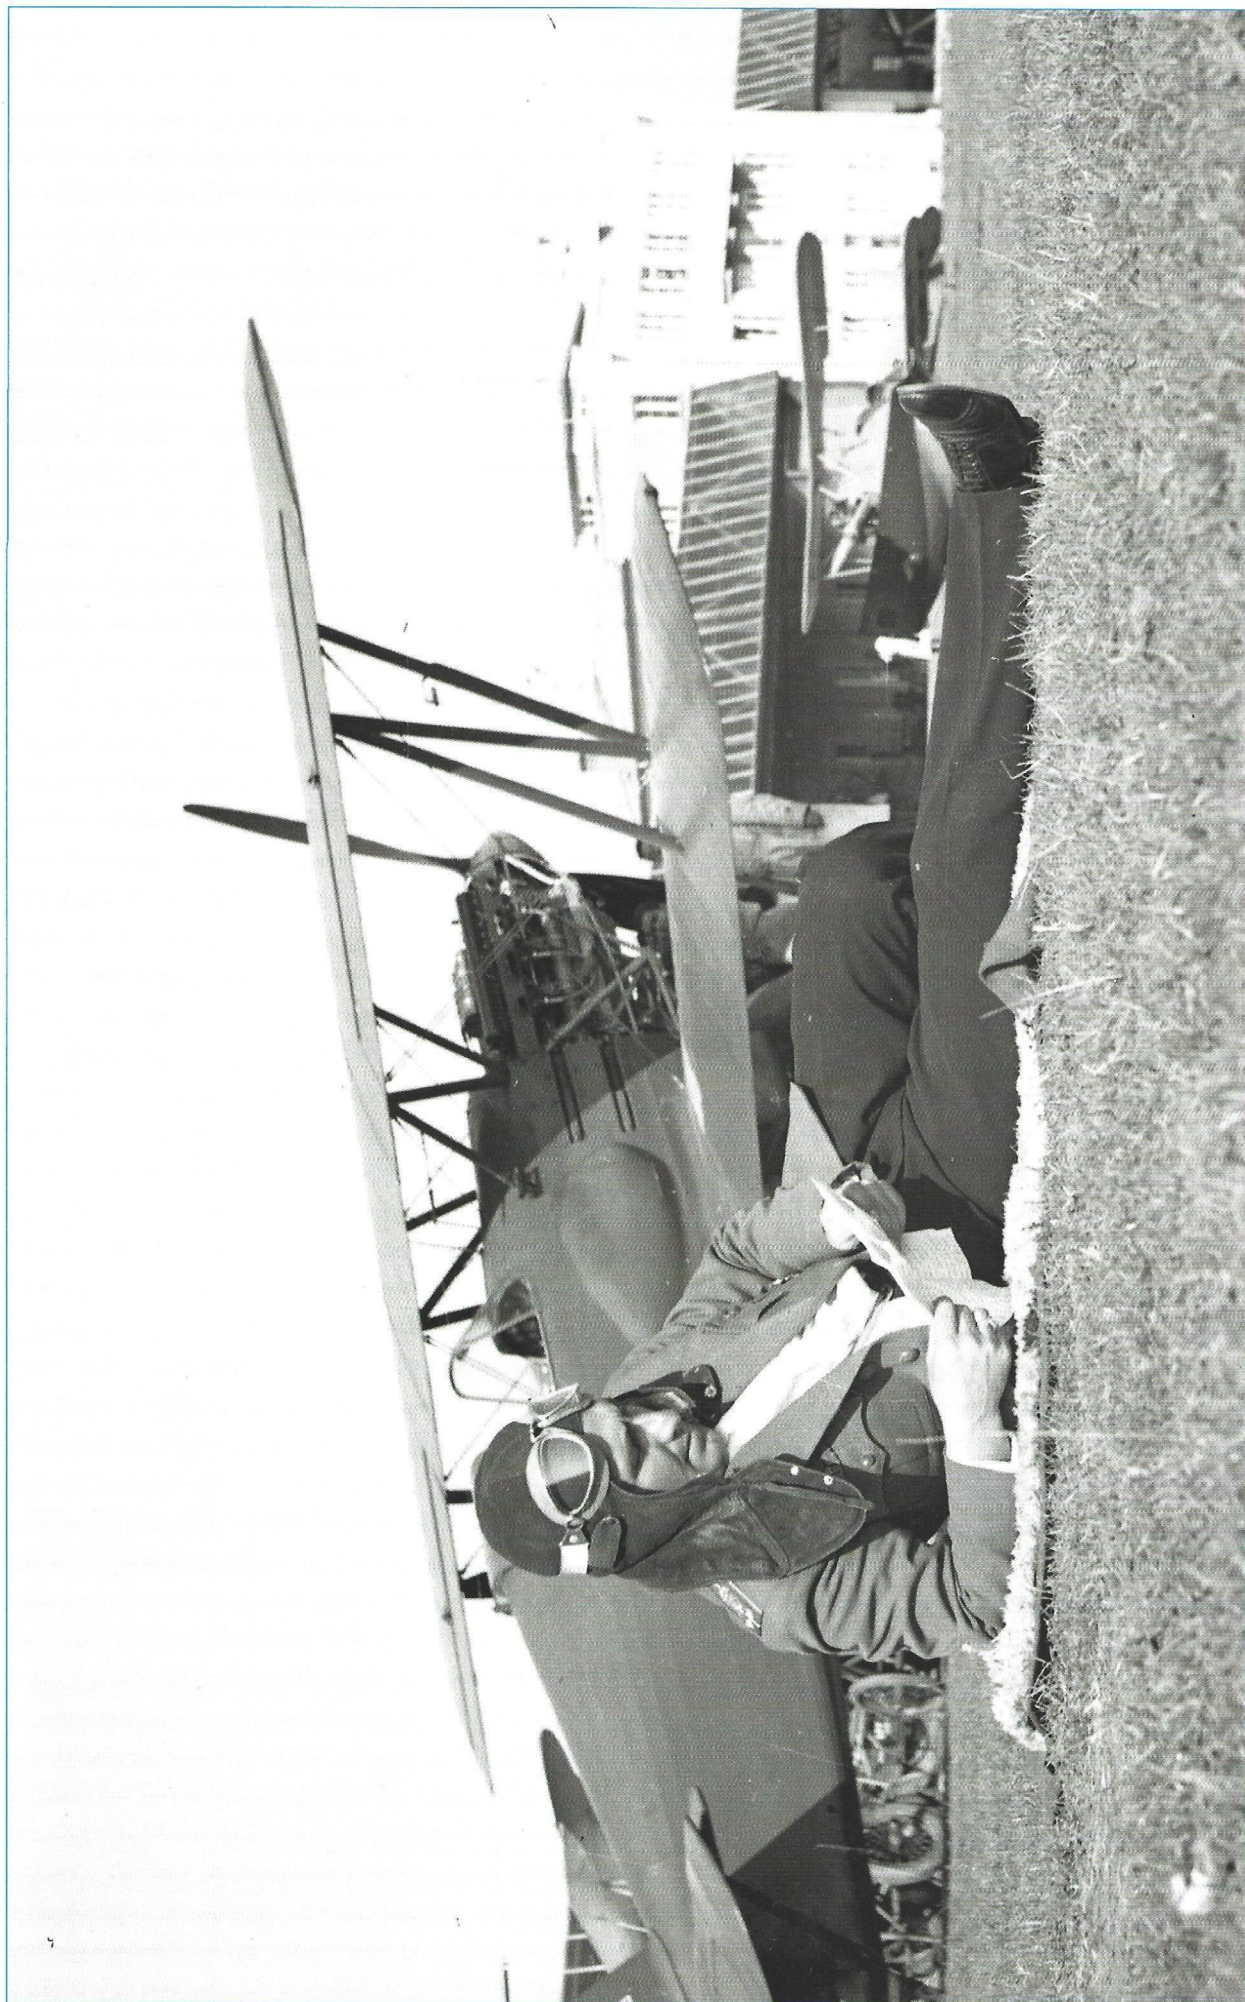
Famous Bulgarian aviator and test pilot Kapitän Inzh. (Capt. Eng.) Petko N. Popganchev enjoys a moment of tranquillity and reads a hand-written letter in front of a freshly assembled Avia B.534, still devoid of any markings. The peculiar Bulgarian identification triangle had been applied on mid-fin; with the Nomenklaturen Nomer (7037) barely visible in the triangle's denominator. A second still reveals the aircraft's individual serial number, written on the top of the triangle: 16. Based on his logbook, Kpt. Popganchev test flew Dogan No. 16 off Bozhurishte air base on 17 April 1940 – the likely date this particular photo was taken.

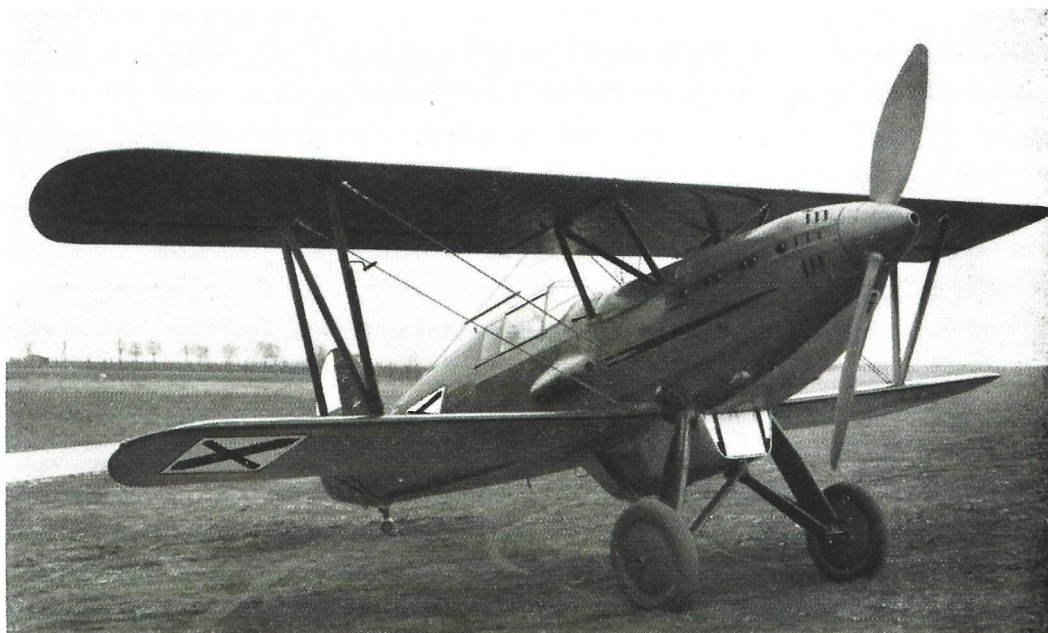
Jagdeinsitzer Avia B. 534

Page scanned from an original copy of *Die Kriegsflyzeuge der Staaten Südost-Europas (Warplanes of the Countries of South-Eastern Europe)*, edited by der Oberbefehlshaber der *Luftwaffe*, published in December 1940, depicting an Avia Bk.534 with false Bulgarian markings. This particular retouched factory photo was copied post war and used by various authors to prove the existence of the cannon-armed version of the Avia fighter in Bulgarian service – which was not the case, however.

The author managed to buy an original copy of an official wartime German booklet published in December 1940, which lists the major aircraft types of South-East Europe, including Bulgaria¹³. To his great surprise, the very same retouched photo of a Bk.534 in false Bulgarian markings (see photo on page 150) was used to illustrate the type's service in the Bulgarian air force! Apparently, this booklet was the original source, taken at 'face value' by post-war Czech and Slovak historians, then spread around unchecked. Therefore, it can be stated that the author found no credible proof of Bulgarian service of the cannon-armed Avia biplane. This makes sense, as except for the first three units, all cannon-armed Bk.534s were manufactured after Czechoslovakia was occupied by German troops. These brand-new aircraft were then used by the *Luftwaffe*, rather than be sold to the poor Balkan ally, which received only used aircraft – fair enough, at a deeply discounted price.

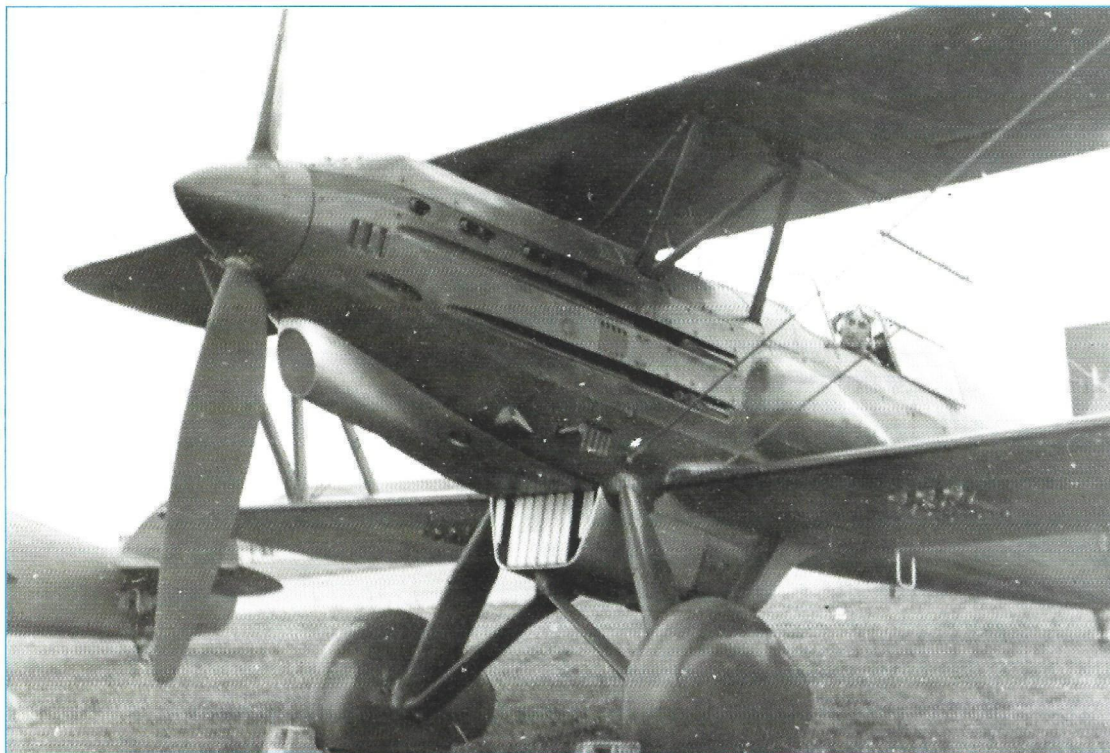
Snapshot of a Bulgarian pilot taken in a freshly assembled Avia B.534 on a cloudy day in the late winter of 1940. There are no markings visible on either depicted aircraft. Notice the three silver coloured underwing bomb racks mounted on both wing surfaces, suitable for 10 kg splinter bombs.

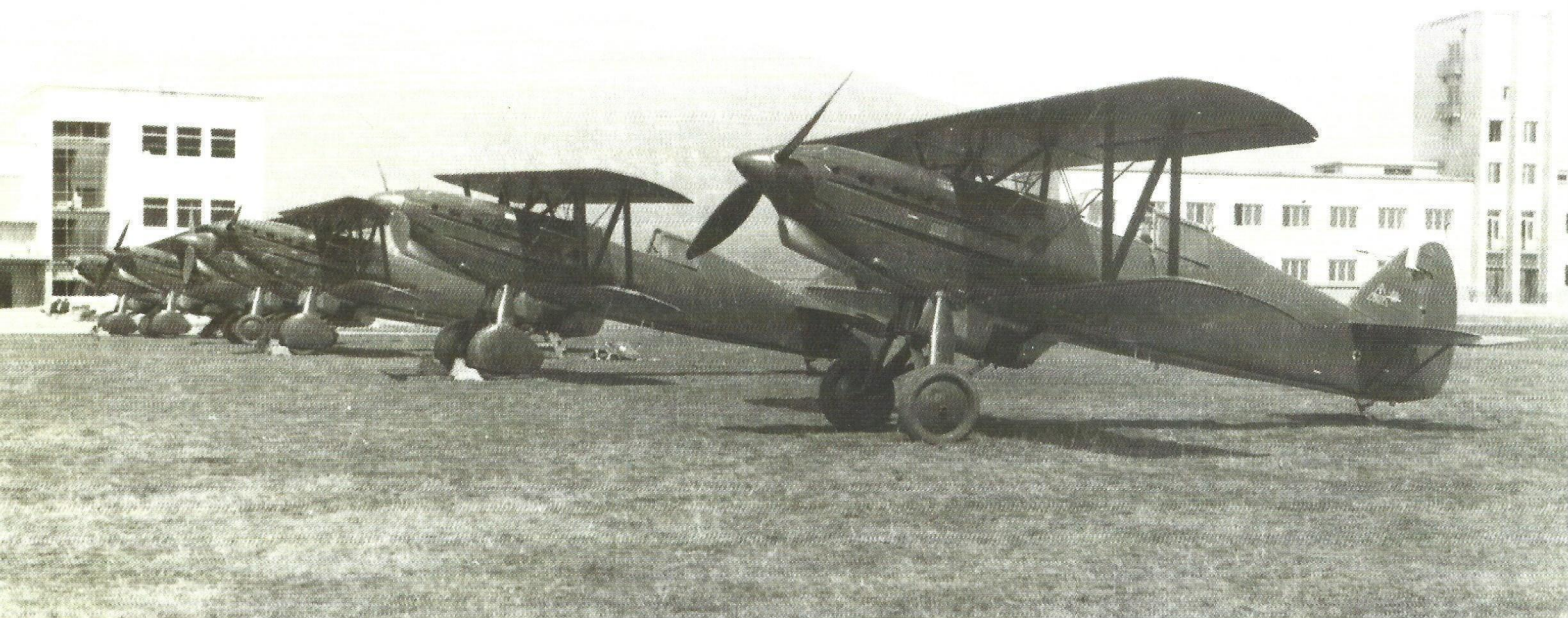
Line-up of six recently delivered Avia B.534s at Marno Pole/Karlovo main fighter air base (the tower typical of this airfield is visible at right, which would be covered in camouflage paint later on). Only a half yato (squadron) is seen on the photo, the other half is probably lined up at left, facing this row, outside the camera’s lens. Closest to the camera, without wheel covers, is No. 5/7037, while the second one might be No. 18, or 19/7037.

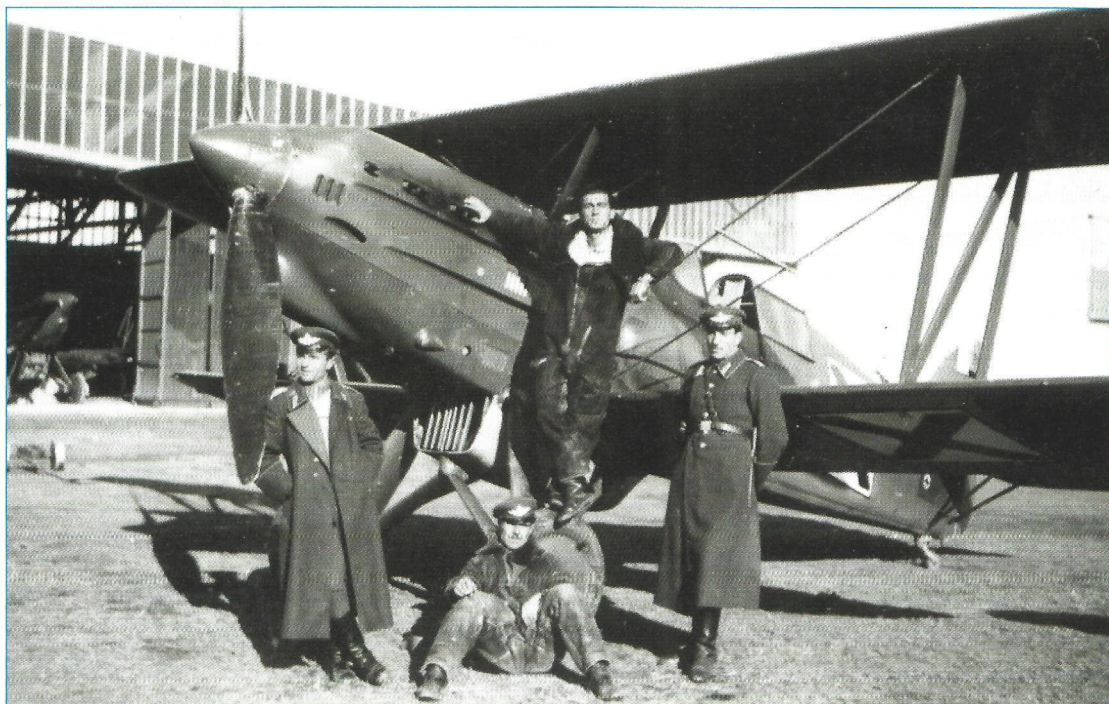
The lower engine cowling of this Dogan was completely painted with a fresh layer of dark green that appears slightly darker than the fuselage's original Czechoslovak-era greenish khaki. The rudder is dark painted, probably khaki like the airframe. The aircraft already carries the St. Andrew Cross-type military marking, consisting of a black X in a black bordered white square, introduced on 26 June 1940. There is no white serial number visible on the fuselage side. These details place the time the photo was taken in 1940, possible in the autumn, due to the warm clothing the airmen are wearing. The other airplane whose nose is seen in the hangar door, at left, also has the lower engine cowling painted in dark green.

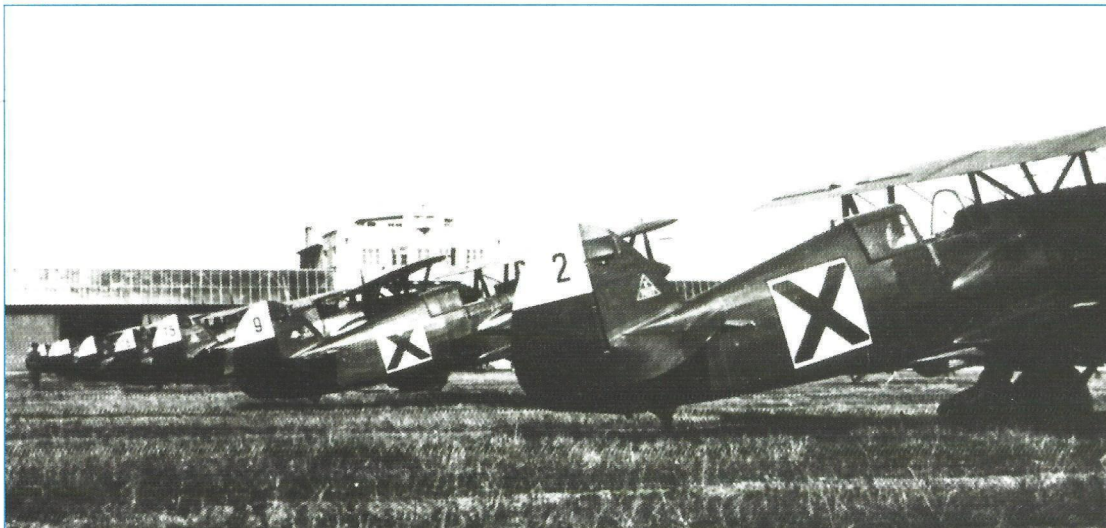
The same line-up, this time seen from the rear. This particular shot reveals that the first four aircraft have their serial numbers repeated in black on the top area of the rudder, painted in white. They are Nos. 2, 9, 75 and 76. However, the last five do not have this identification feature applied yet.

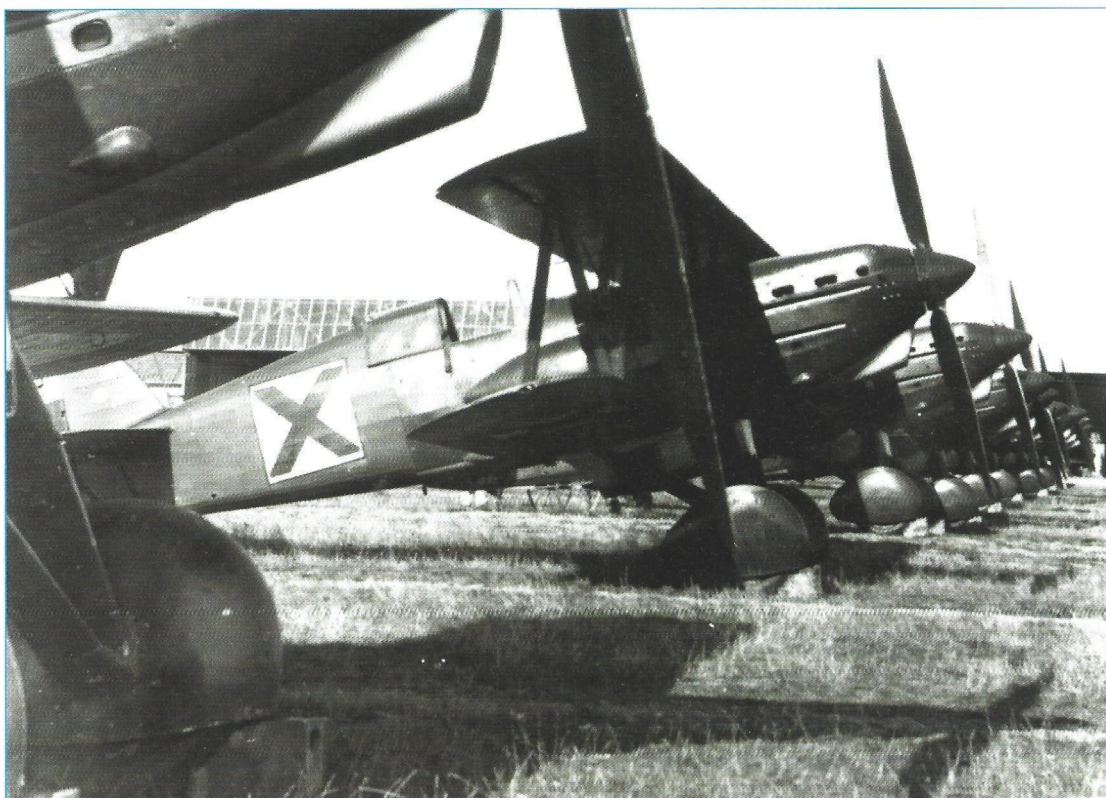
The third view of the same row focuses on aircraft No. 9, an Avia B.534-IV. Note the different reflection of the same Czechoslovak Air Force khaki green camouflage colour off the fabric-covered rear fuselage and off the metal skin front fuselage. A German document dated 1 June 1940 lists sixty combat-ready Avia B.534s, but categorises the fighter type as '2nd class' only.

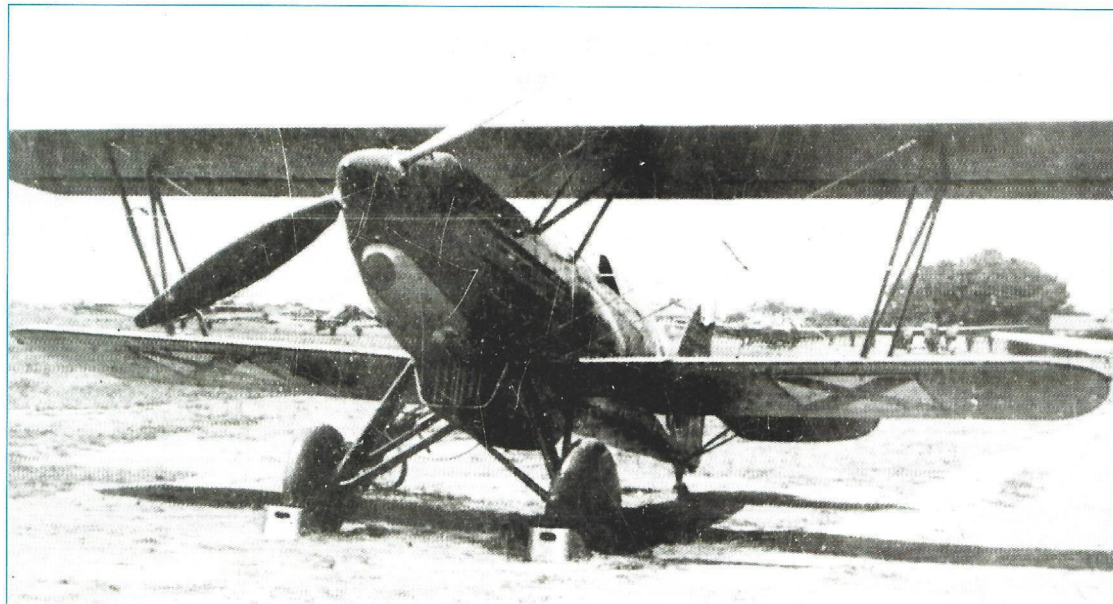
An unidentified Dogan, seen from 11 o'clock. It may have been part of one of the fighter yata of the four army-assigned air polkove, operating the Avia B.534. This possibility is supported by a variety of single- and multi-engine aircraft types seen in the background, just over the lower wing (a Junkers Ju 52 wing at extreme right, an Avia-MB.200 at right with an Avia B.71 near it, while at left a Letov Š.328 and a PZL.43 can be observed, just underneath the propeller blade). There is no yellow Axis identification colour applied yet, dating this photo pre-April 1941.

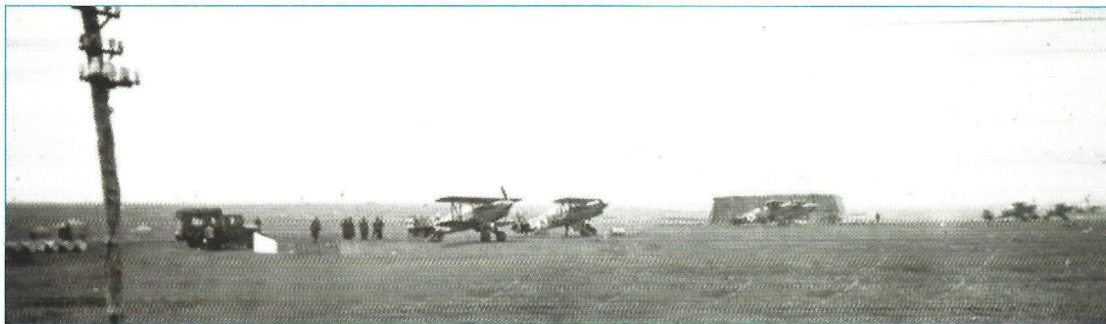
This photo was taken by a German soldier passing by one of Sofia's two military airfields on 8 April 1941. Barely visible in the background are three pairs of Avia B.534s, moved there from Karlovo for defence of the capital. The slow Dogans were unsuccessful in intercepting the faster Yugoslav Dornier Do 17K bombers attacking Sofia.

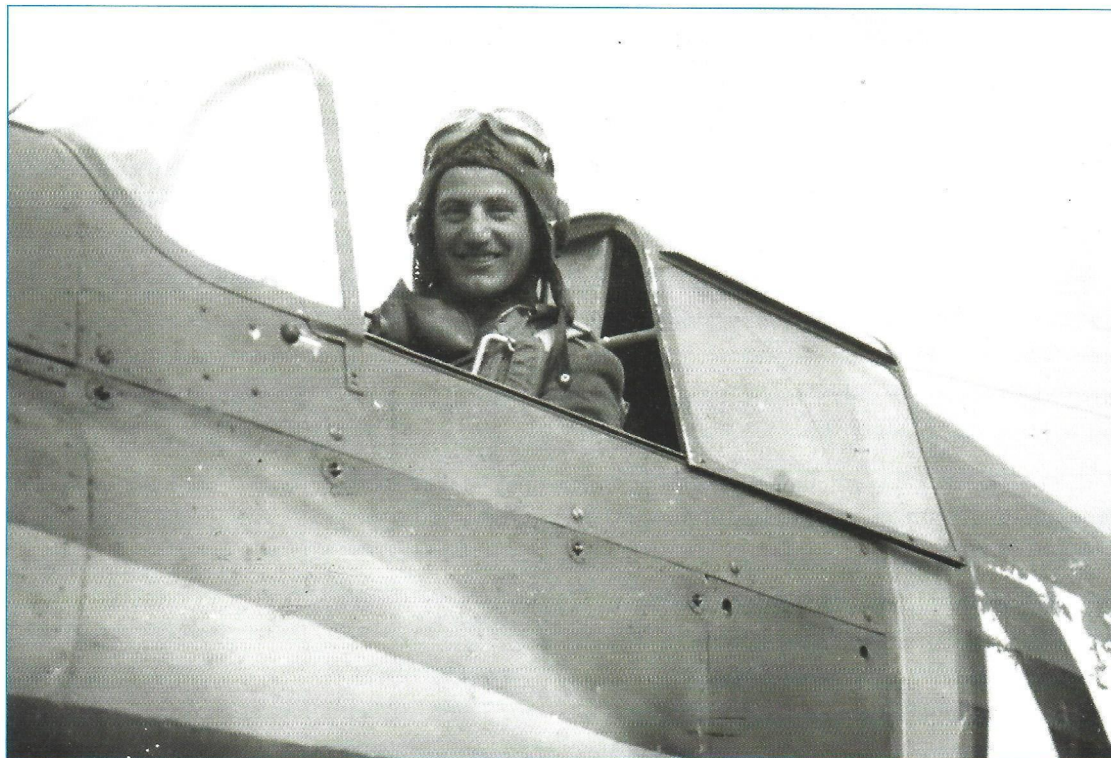
Dogan pilot Podofitser Vasil Shterev, member of the 1st Army Air Polk, seen in the cockpit of his mount, in the second half of 1941. Notice the thin, yellow mid-fuselage band just aft of the cockpit and the heavy weathering of the Bulgarian national marking. The aircraft is already adorned with the rearward tapering yellow fuselage 'flash', typical of fighters and fighter trainers.

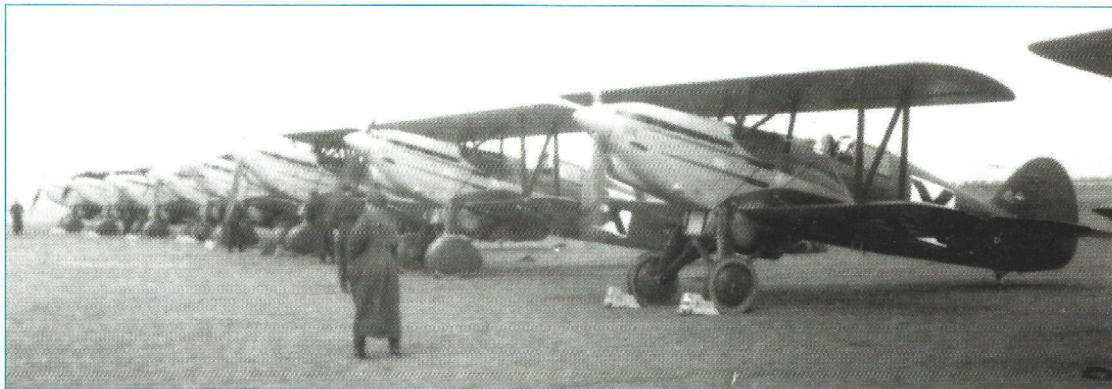
Nine Dogans are lined up on the field, probably during manoeuvres, presumably in late 1941. They all have their nose sections painted yellow, which continued in a rearward tapering flash along the fuselage. There is no yellow recognition colour applied anywhere else. The aircraft's serial number is not yet painted on the fuselage side, aft the national marking, as it was the case later on.

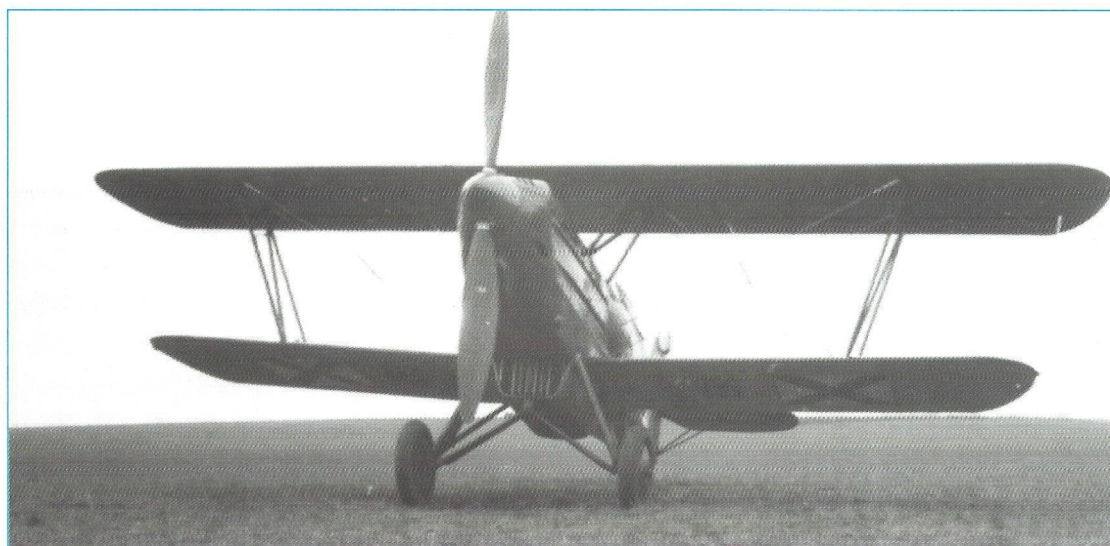
This eleven o'clock view of a lone 'Dogan' parked somewhere in the field does not reveal much details. Unfortunately, in this particular case the black serial number was not applied on the lower wing undersurface, thus the aircraft's identity remains unknown.

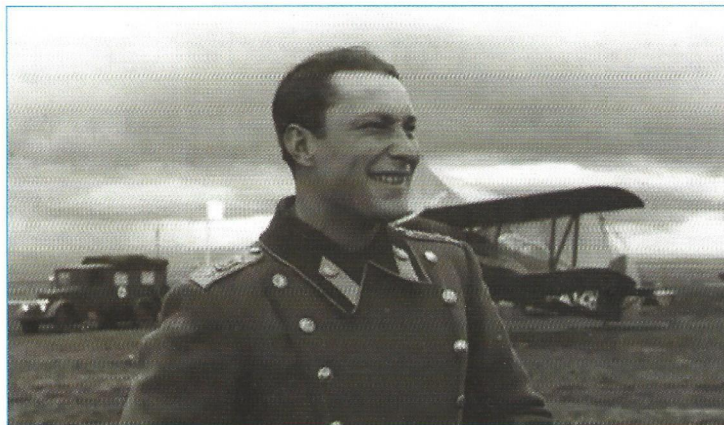
Would-be Bulgarian national hero, Por. Dimităr S. Spisarevski, smiles broadly during autumn manoeuvres (see large tent in the background). Dogan No. 28, believed to be part of the 222. Orlyak, offers a suitable background. Notice the yellow rudder and port elevator.

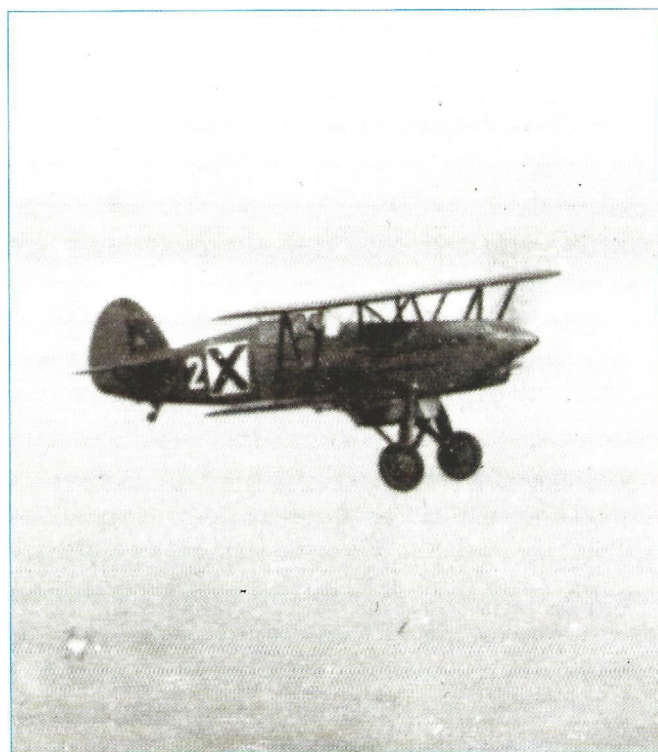
Dogan No. 2 of the 442nd Yato, 4th Army (Air) Polk, patrols the area around Pomorie, over the shores of the Black Sea, in late 1941. The cockpit canopy is slid rearwards, for better visibility and audibility. Due to the type of the negative film, the yellow mid-fuselage band, rudder, elevators and engine cowling appear in very dark shade, almost the same as the greenish khaki upper camouflage paint.

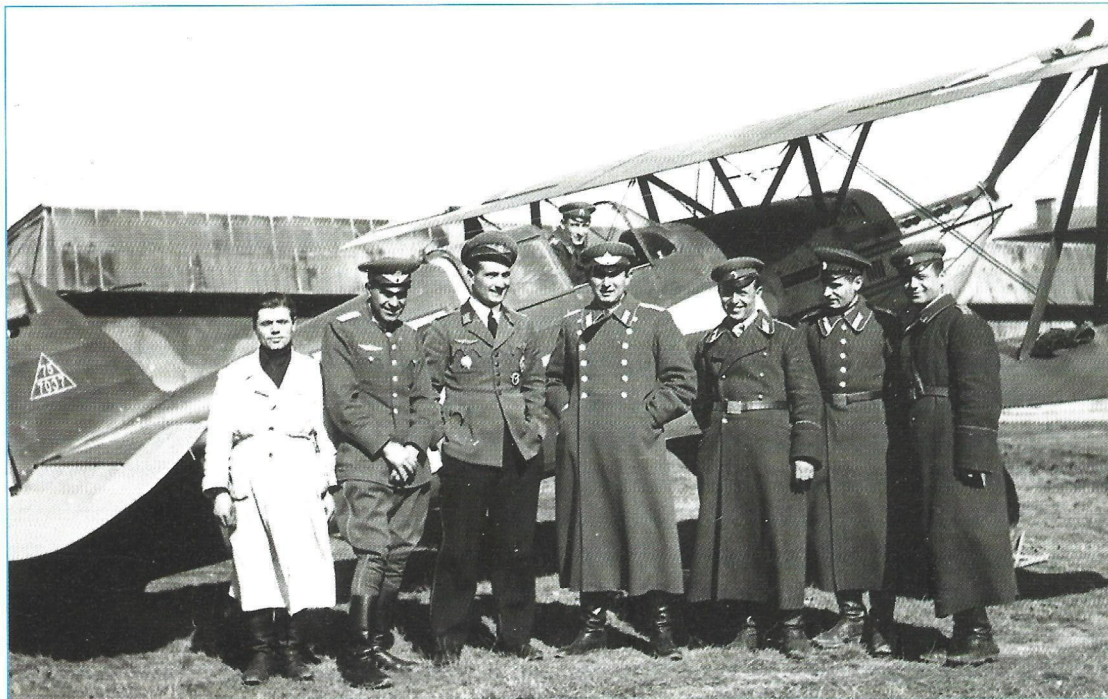
Dogan NN 75/7037 wears the most extensive yellow markings ever observed on Bulgarian warplanes: bottom and upper wingtips, wrap-around nose and fuselage 'cheatline', mid-fuselage band, rudder and elevators. The tallest airman (third from left) is the venerable Cpt. Petko N. Popganchev. This particular aircraft was officially written off on 4 September 1945.

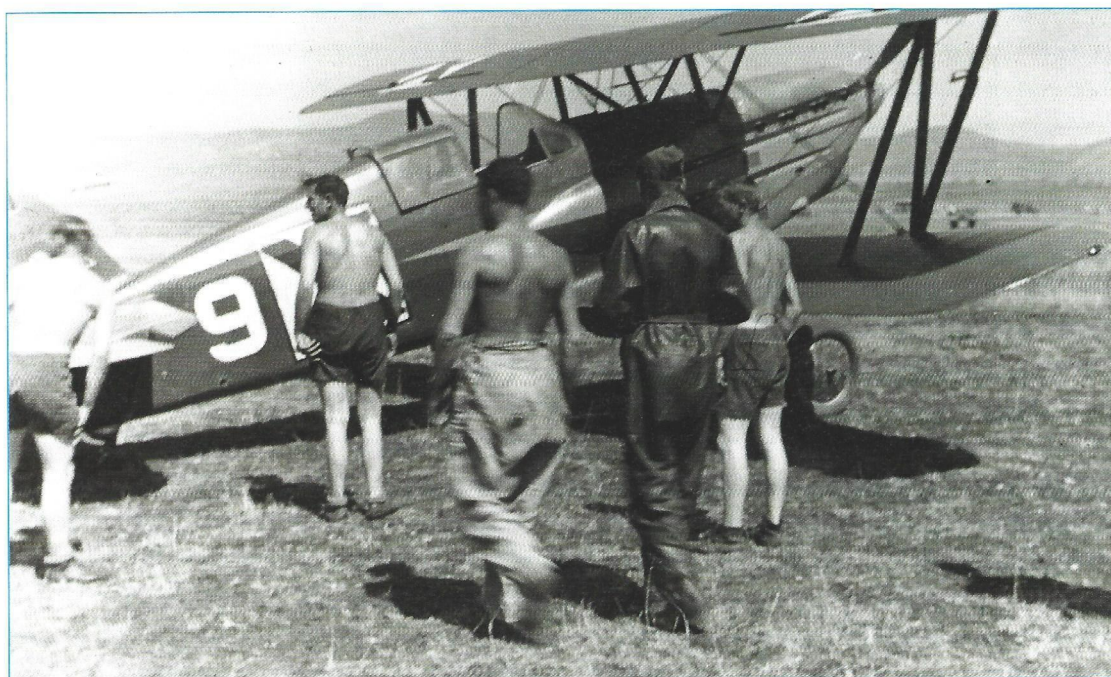
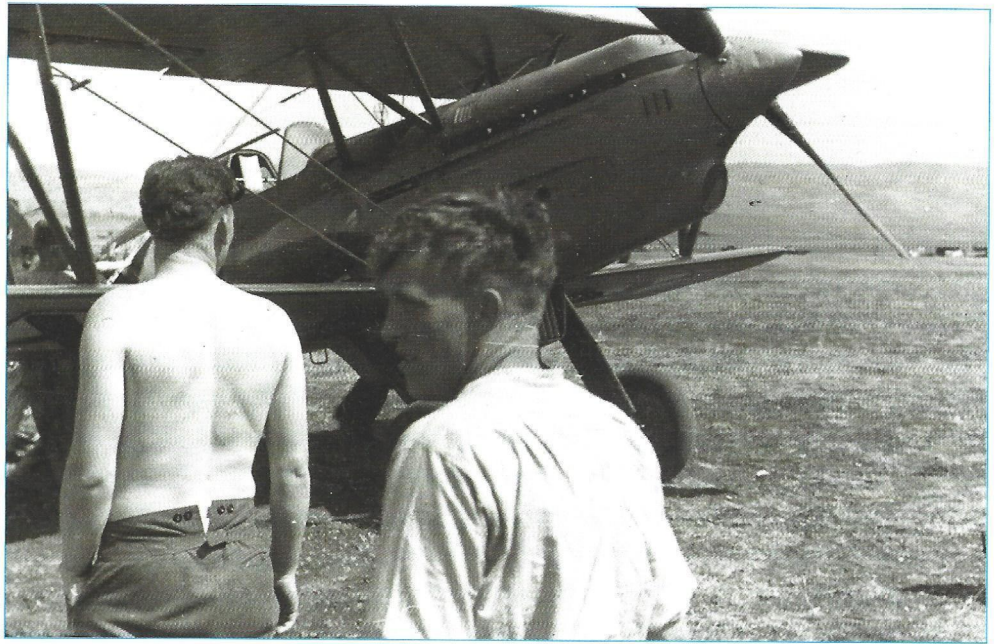
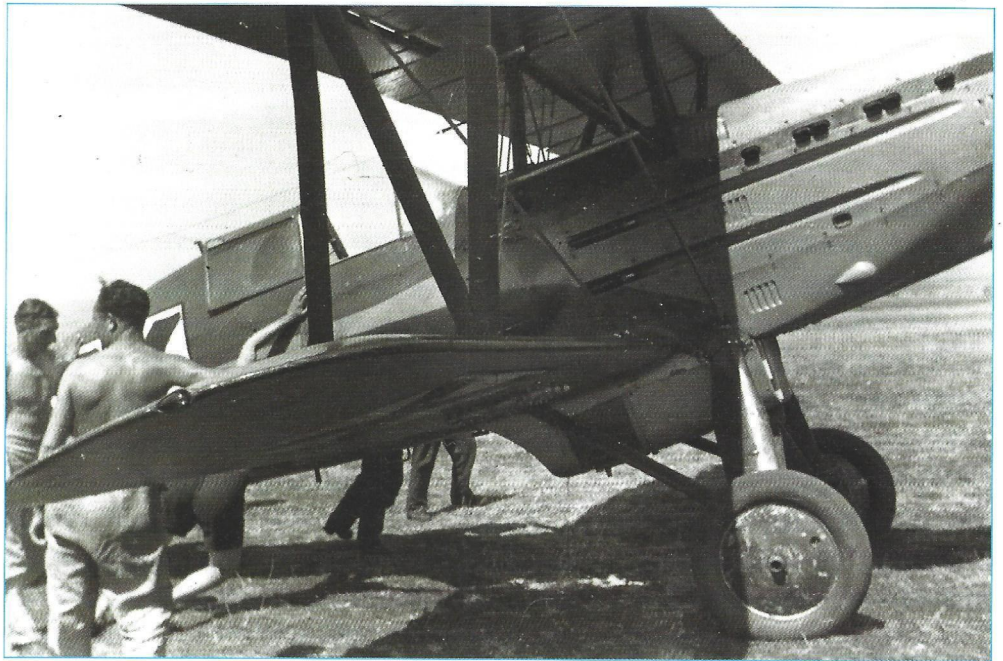
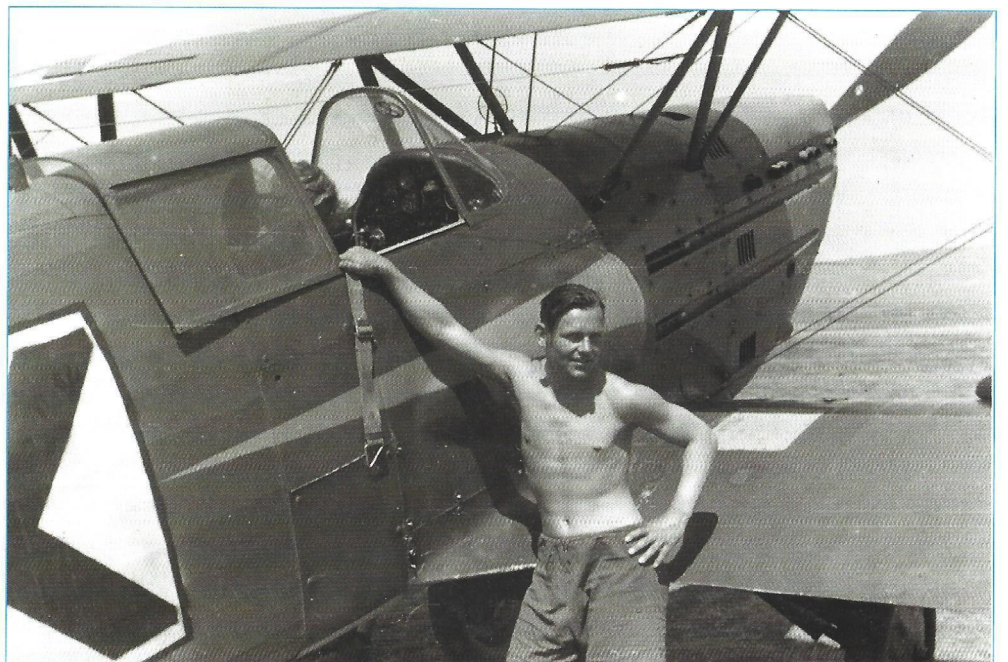
This and next page: This series of four photographs depicting *Dogan* No. 9 was taken by a German officer, Oblt. Reinartz, probably while he was stationed in Bulgaria in the late spring of 1941. Various details, not usually seen in lesser quality photos, can be studied (including the ventilation scoop built into the upper windshield).

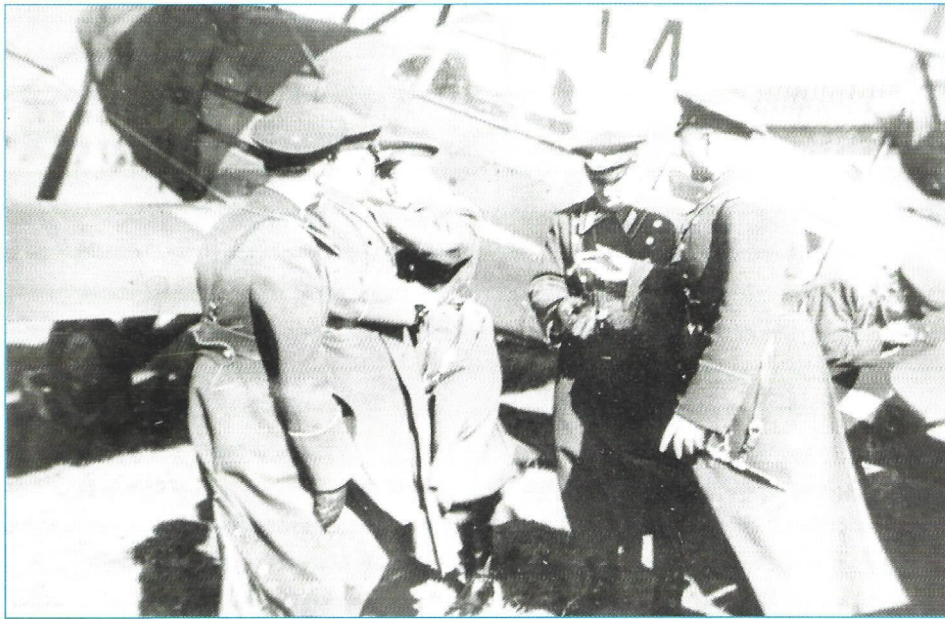
Senior air force officers gather around a parked Dogan on a frigid day of 1941.

The aircraft in the background wears the mid-fuselage band and yellow nose plus flash. Unfortunately, the officer leaning forward partially covers the aircraft's white serial number; however, enough of it is still visible to lead to the conclusion that it might be No. 24.

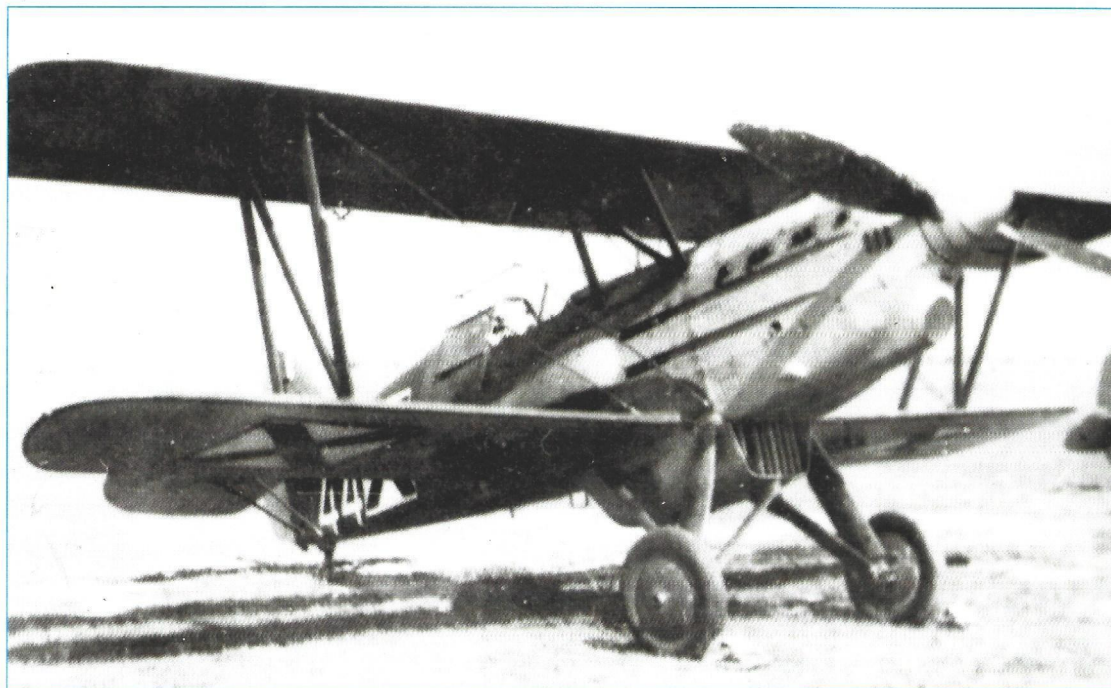
Dogan No. 44 is parked at the edge of the landing ground. The tarpaulin cover is removed from the engine and cockpit, which indicates the aircraft is about to be flown, or maintained.

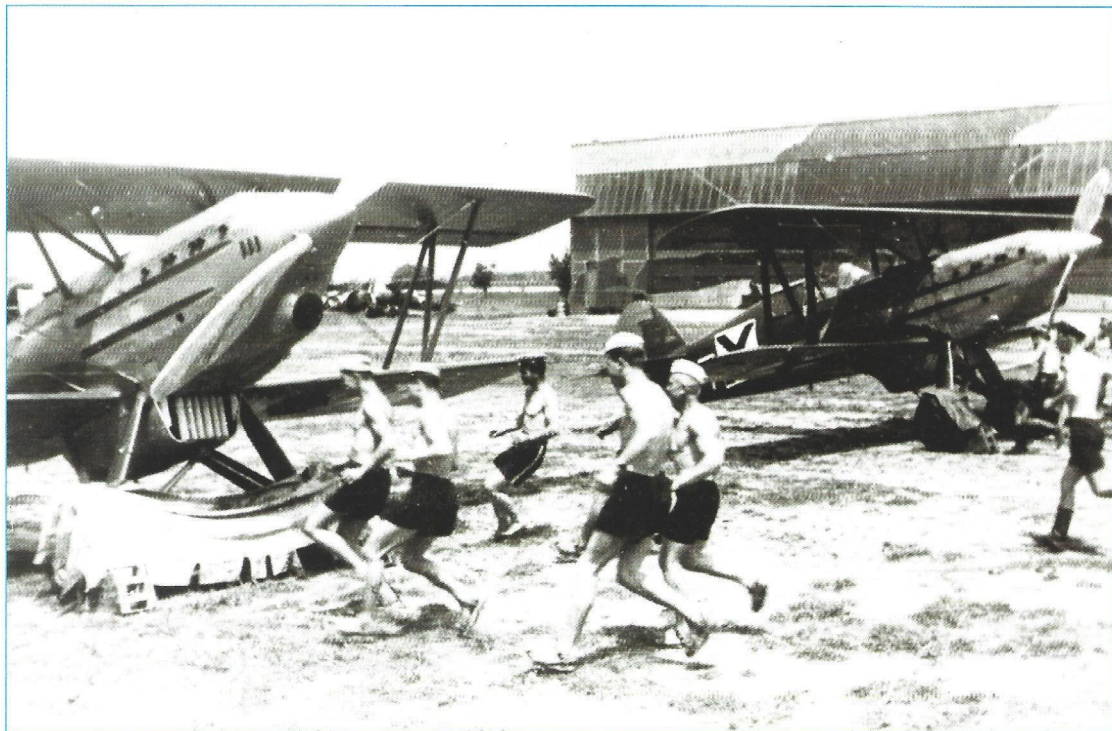
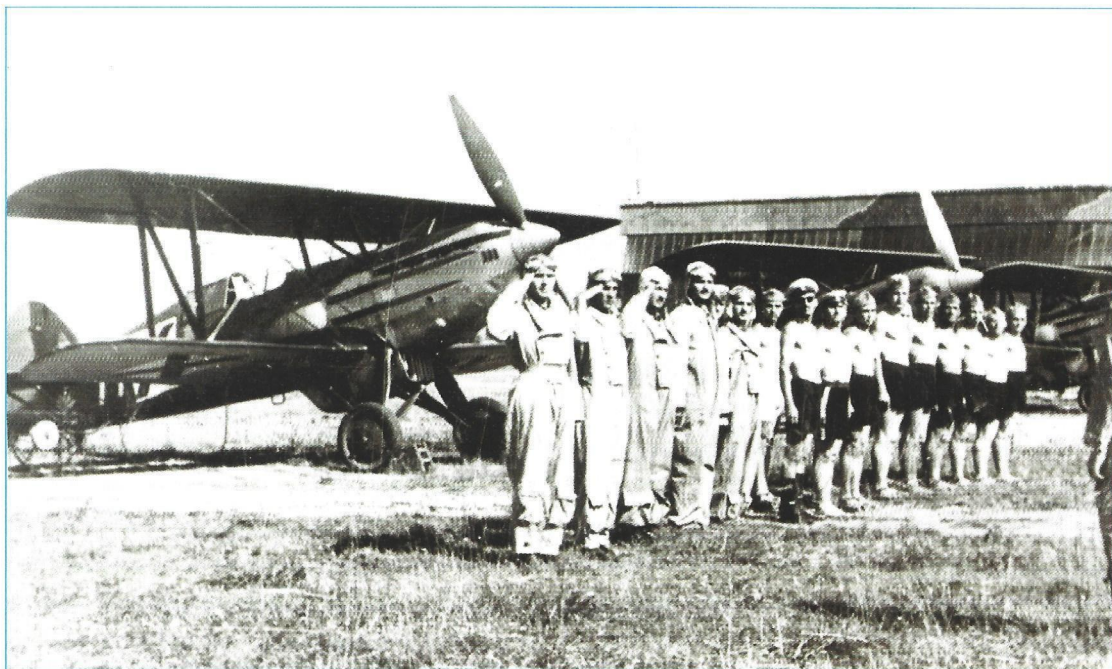
This pair of photos depicts a Dogan krilo during drills at Marno Pole/Karlovo airfield, in the Summer of 1942. The three pilots of the krilo (i.e. three-aircraft basic formation) are saluting their commanding officer after receiving their orders. Depicted is Avia B.534, No. 77 – the highest serial number identified on photographs and in documents. In the background of the top photo, a couple of old PZL P.24bs are visible, lined up near the hangar.

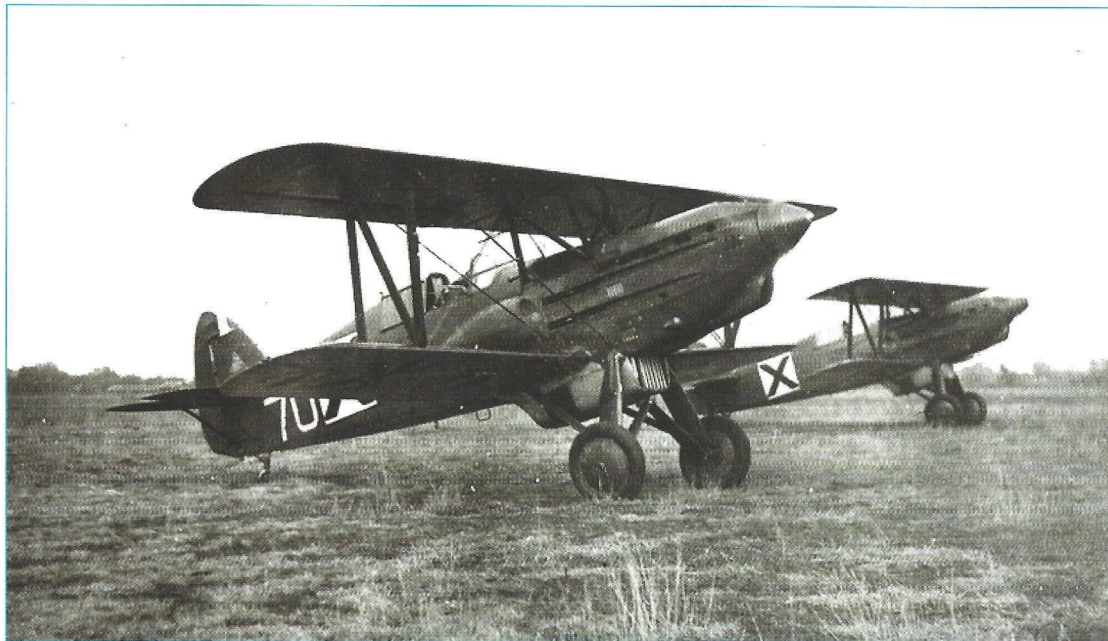
Curiously, although the aircraft in the foreground has its serial number applied on the rear fuselage, the one in the rear (which was a B.534-V, not a B.534-II, or -III, as it may appear to the inattentive onlooker), has not. Photo believed to be taken at Buhovtsi landing ground, near Shumen, in 1941.

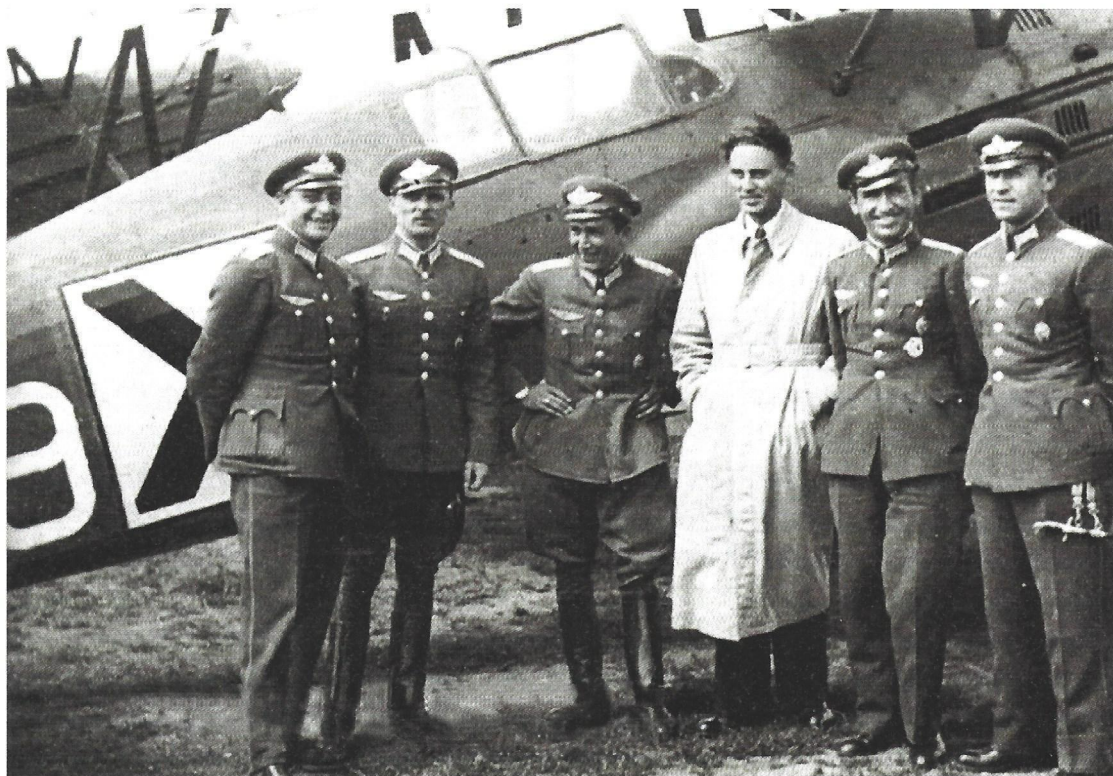
Unfortunately, the full serial number of this Avia B.534-V is not seen on the photo; however, the last digit appears to be 9. If so, a photo included on page 167 shows a different style numeral on the rear fuselage. The third man from left, with arms akimbo (i.e., hands on hips), is Ppor. Nedelcho D. Bonchev of the 652nd Yato. Bonchev ended up sixth in the ranks of top Bulgarian fighter pilots, with two confirmed 'Fortresses' shot down and a 'Liberator' damaged, amounting to 8 victory points. This particular photo is often located by various Bulgarian publications to "Piacenza airfield, Italy", which was certainly not the case.
